Technical Evaluation of the Gold King Mine Incident

San Juan County, Colorado

U.S. Department of the Interior
Bureau of Reclamation
Technical Service Center
Denver, Colorado

October 2015

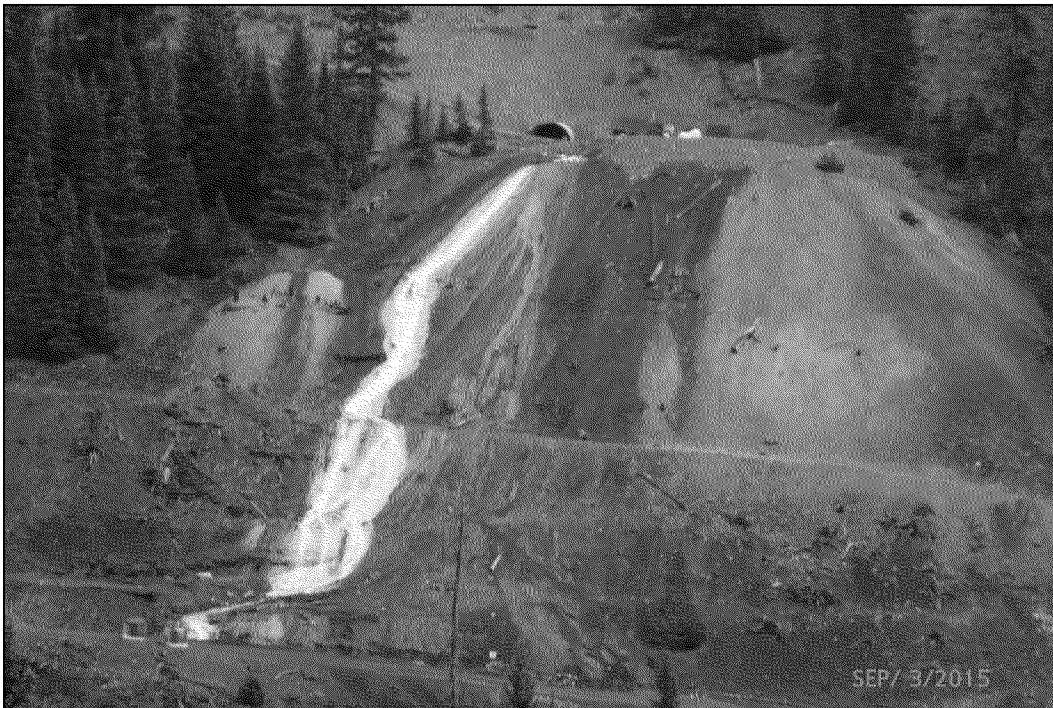
Figure 11.—Photograph showing acid drainage flowing out of the Red and Bonita Mine on September 3, 2015.

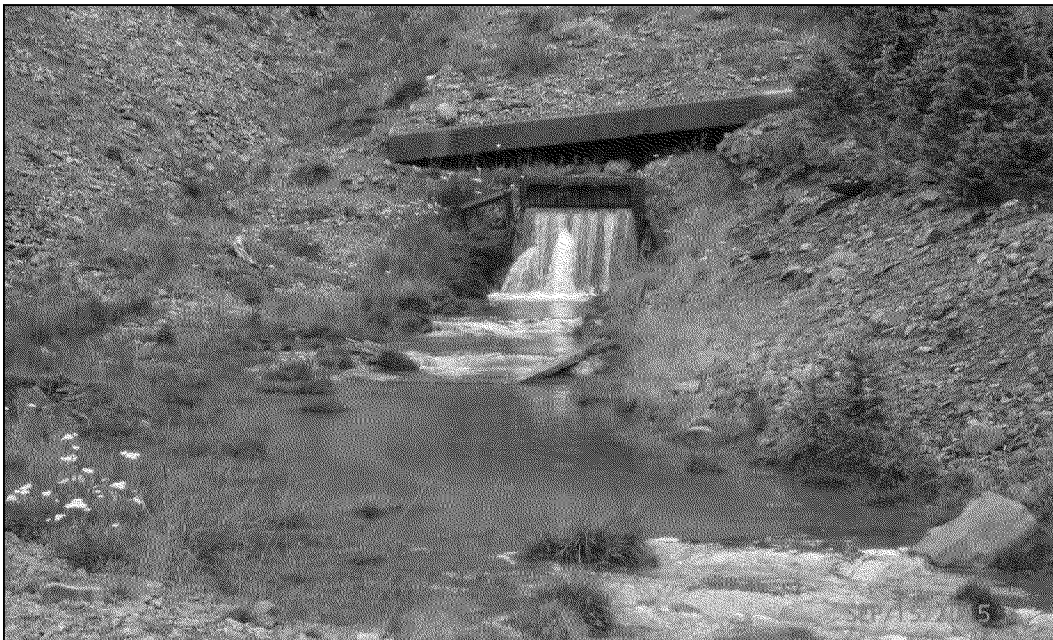
Figure 12.—Photograph taken on September 15, 2015, of drainage from the Silver Ledge Mine, which is located south of the Gold King Mine.

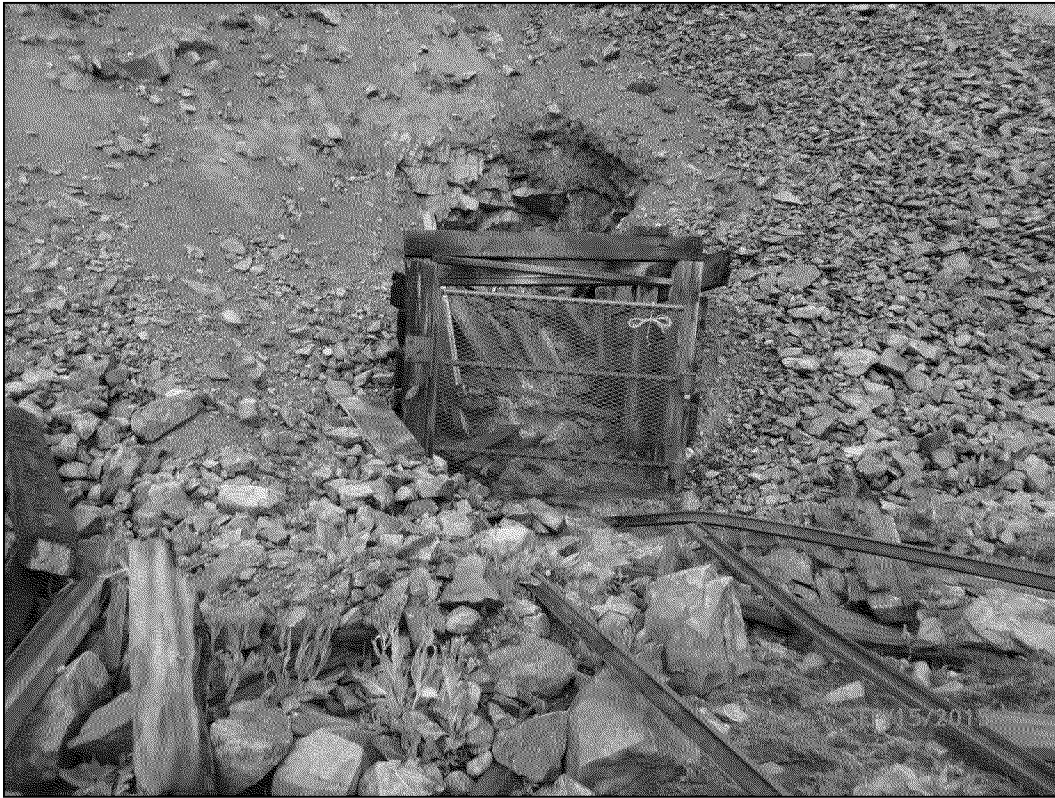
Figure 13. Photograph taken on September 15, 2015, showing acid seepage from the Blackhawk Mine located south of the Gold King Mine.

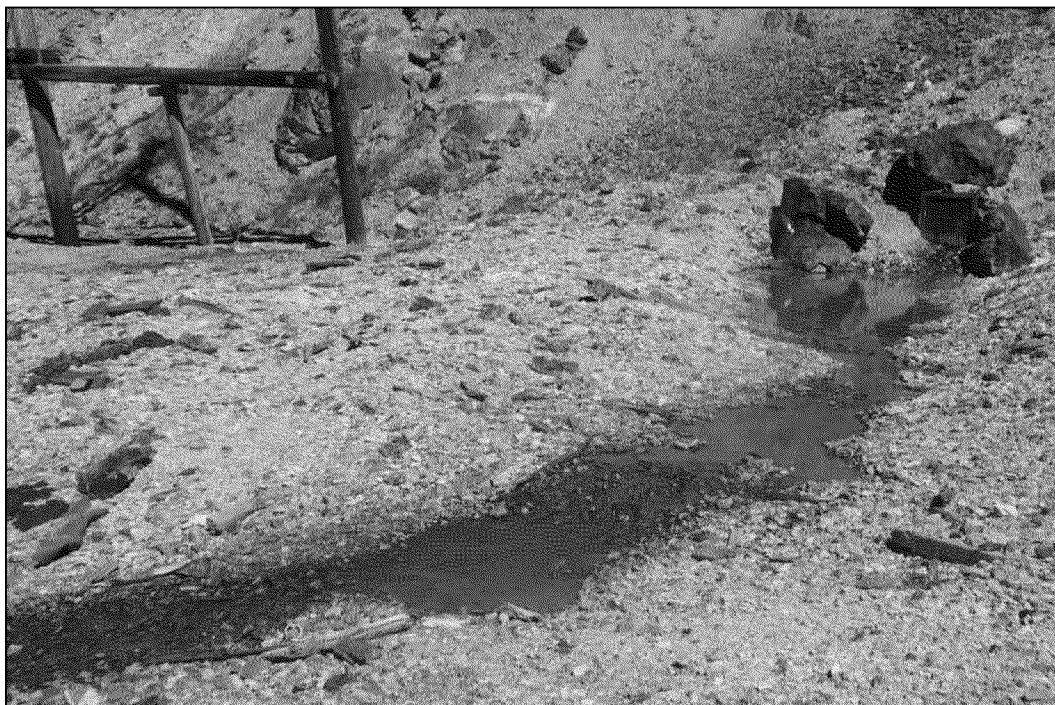
Figure 31.—Gold King Mine Level 7 OLD Adit (upper right) showing a small amount of seepage flow on September 11, 2014. At the portal, the floor of the old adit is approximately 2 feet higher than the floor of the old adit portal (photograph from EPA project files).

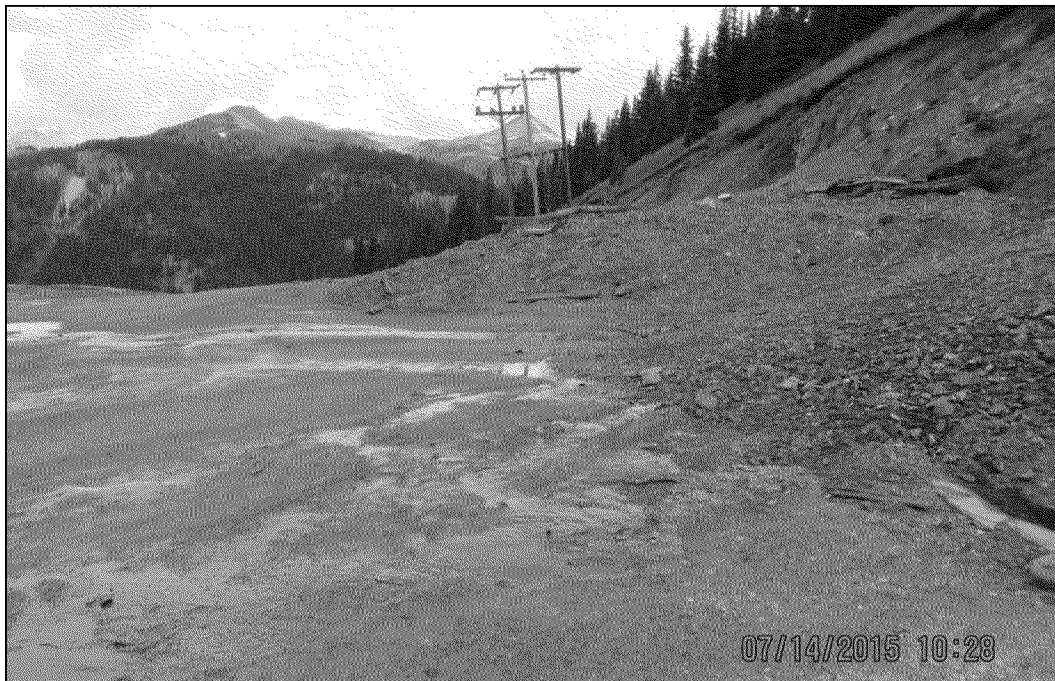
Figure 33.—Photograph showing the condition of the Gold King Mine Level 7 Old Adit portal area on July 14, 2015. Note that more soil and rock had slid from the slope area and had buried a portion of the concrete diversion channel including the ends of the two drain pipes (photograph from EPA project files).

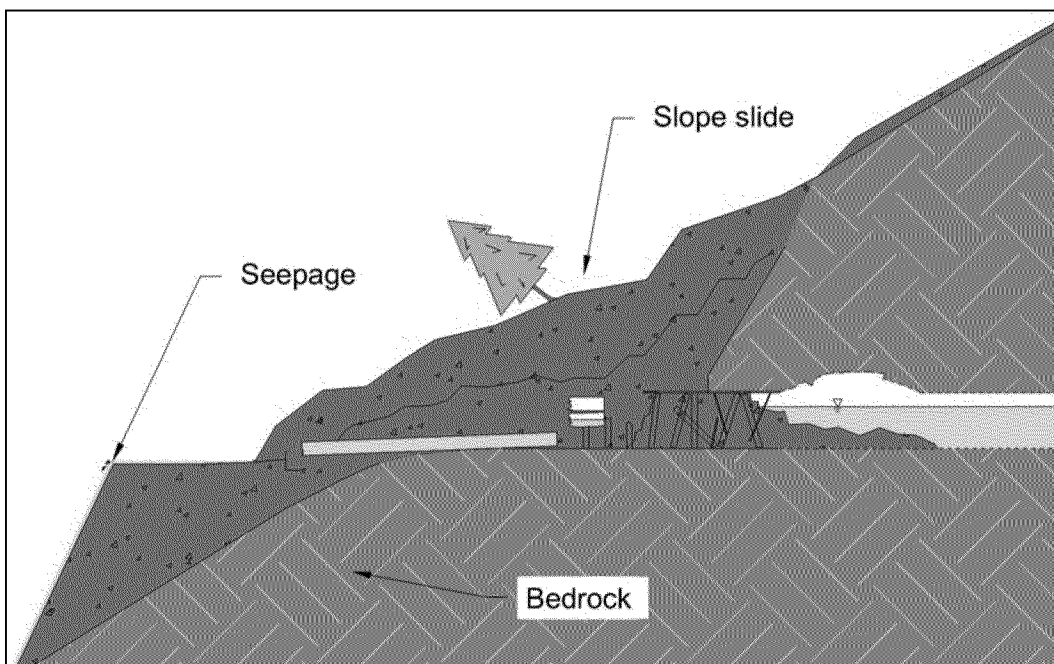
Figure 34.—Cross-section showing the condition of the Gold King Mine Old Adit on July 14, 2015 (water level as assumed by EPA and DRMS), when EPA returned to the site to begin work. More rock and soil and a tree had slid down onto the drains, and seepage was again saturating part of the waste-rock dump (not to scale).

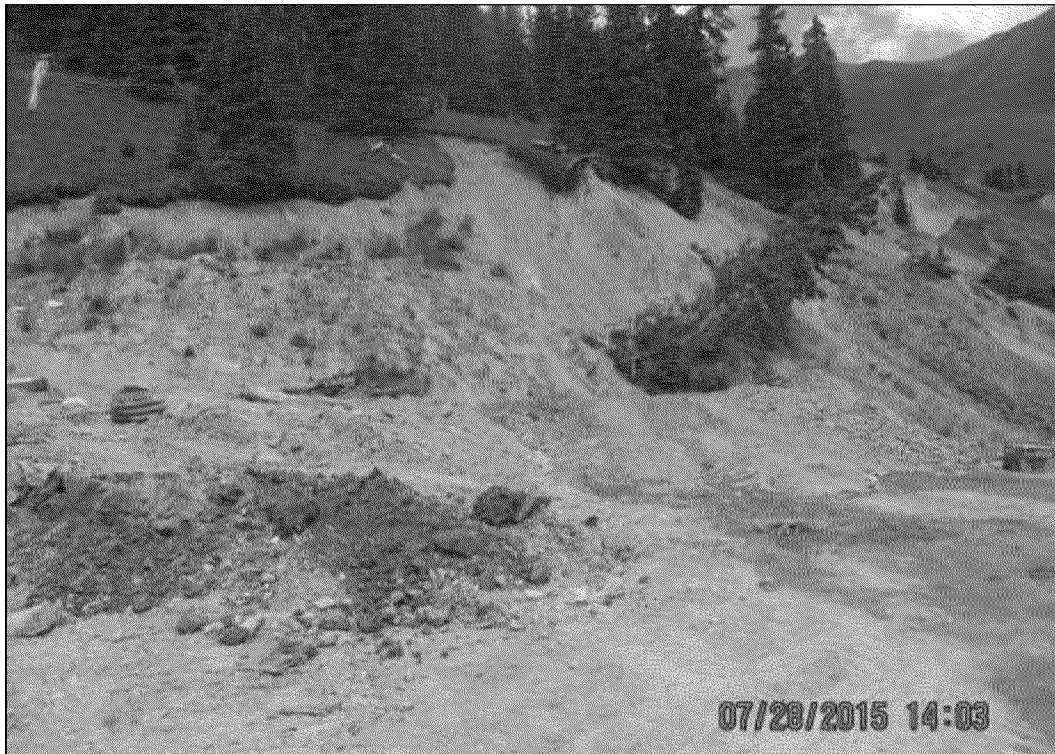
Figure 35.—Photograph showing the condition of the Gold King Mine Level 7 New Adit portal area on July 28, 2015. Note the soil and a tree that has slid downslope onto the portal area; at this time the seepage had been returned to the concrete trough, and the dump was drying out (photograph from EPA project files).

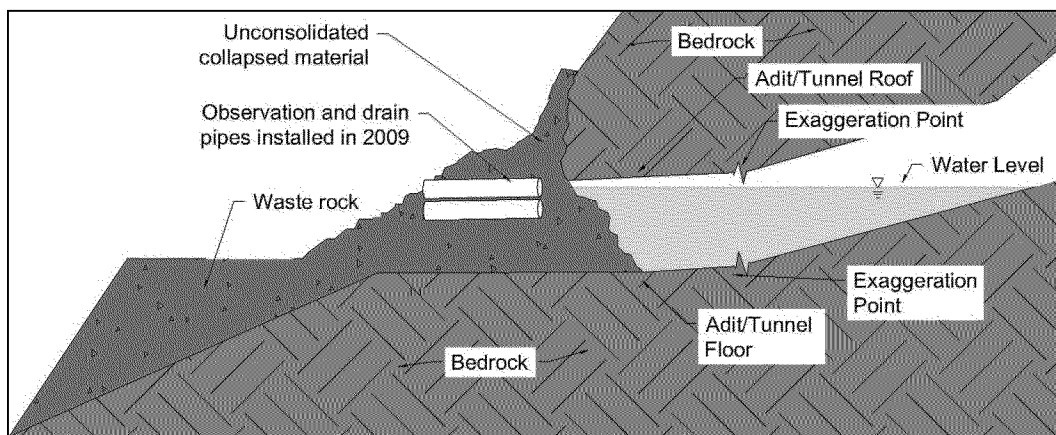
Figure 40.—Cross-section illustration showing the condition of the adit that was assumed by the EPA OSC and the abandoned mine experts from DRMS for use in planning to open the adit (not to scale). The “exaggeration point” means the right side of the drawing has an exaggerated vertical scale in order to show the 1% uphill slope of the adit. If drawn without exaggeration, the uphill slope of the adit would not be obvious on the drawing.

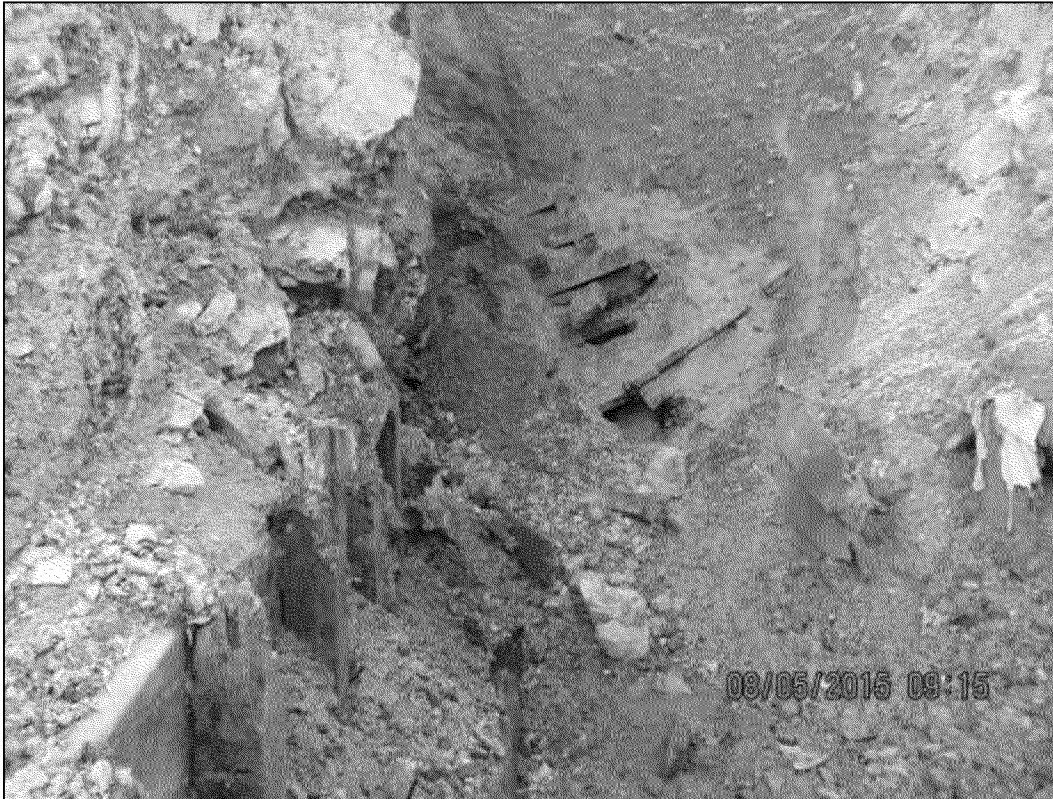
Figure 46.—Photograph taken at 9:15 a.m. August 5, 2015, showing the Gold King Mine Level 7 New Adit excavation uncovering mine timbers and lagging (photograph from EPA project files). Minor seepage is visible just to the left of the date stamp where a small puddle has formed. Note the soil in the upper end of the excavation above the timber lagging.

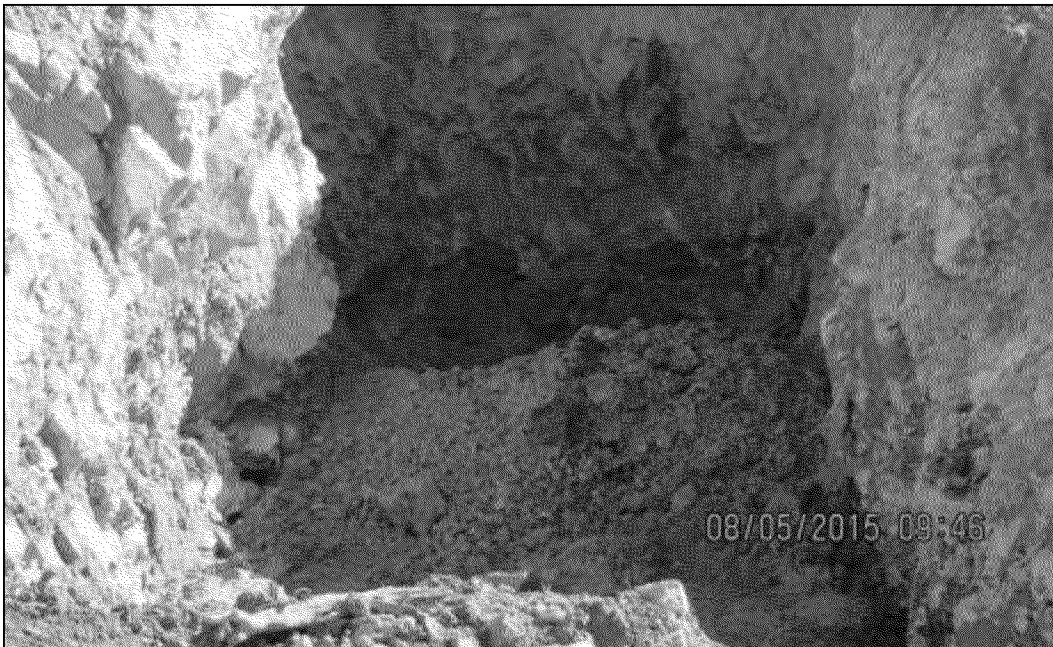
Figure 47.—Photograph taken at 9:46 a.m. August 5, 2015, showing that the loose soil from the upper end of the excavation had been removed exposing fractured and crumbly rock (photograph from EPA project files). The fill derived from the excavation had now covered the timbers, lagging, and seep visible in the previous photograph (figure 46). This indicates that the bottom of the excavation was about 10 feet above the level of the floor of the adit; this corroborates reports that they were digging high, trying to stay above the assumed water level in the adit.

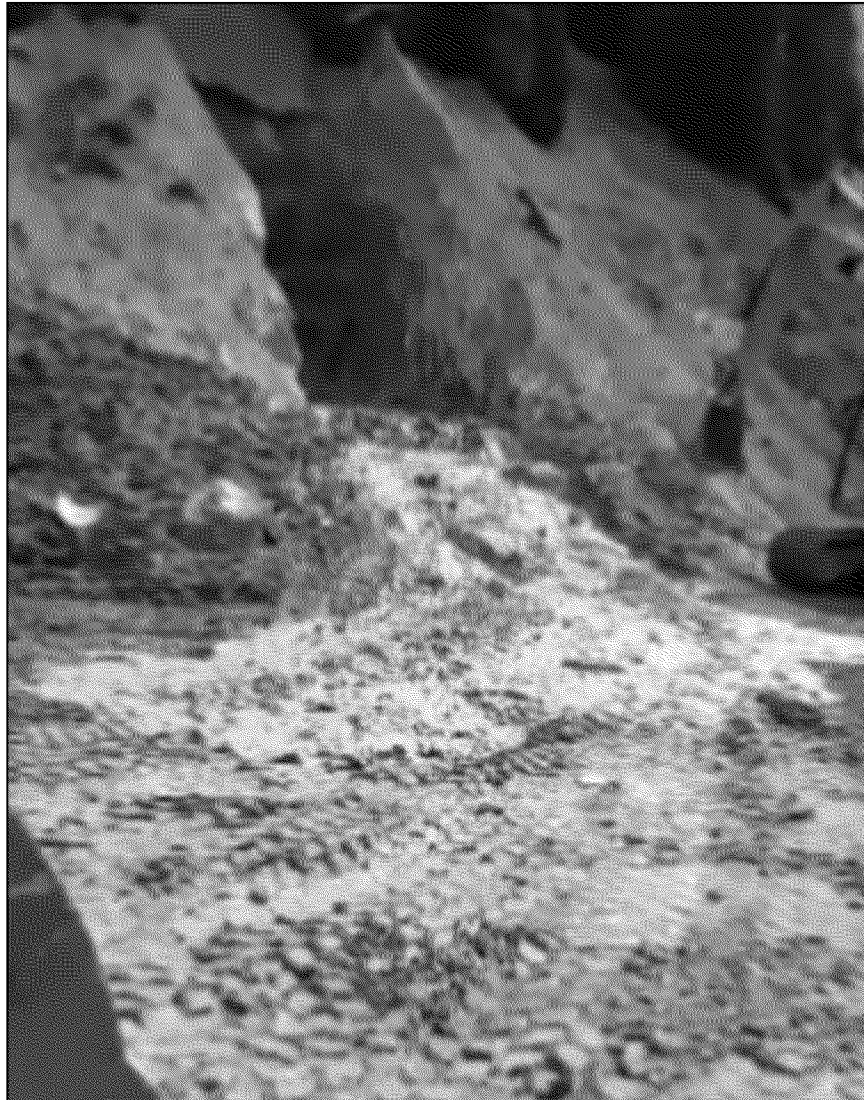
Figure 52.—Photograph showing the initial blowout from the adit. At this point, the flow is surging up over the backfill that was present in the portal area (still frame extracted from a video taken on August 5, 2015, at approximately 10:55 a.m.).

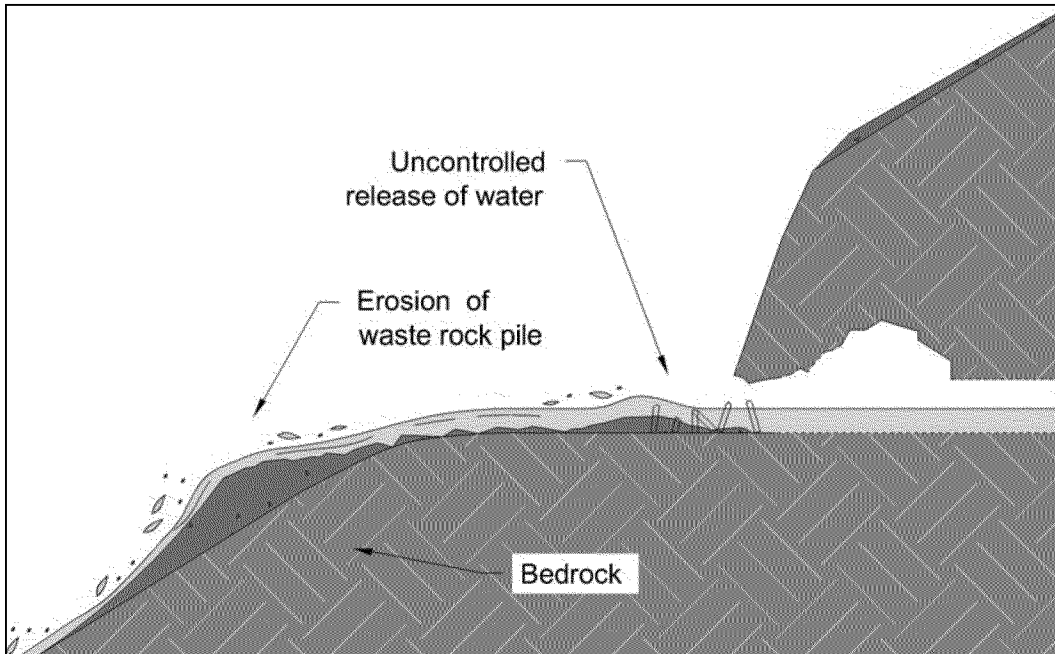
Figure 55.—Cross-section showing the blowout as it eroded the blockage and eroded fill from the waste-rock dump (not to scale).
